Model Number : F6U-1

Model Name : Pirate

Model Type: Fighter

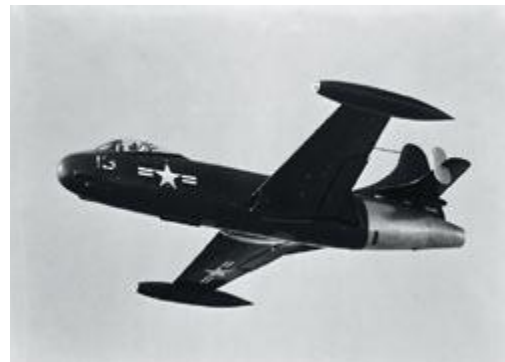
The F6U-1 was equipped with an afterburner and wing tip tanks. The vertical-tail and horizontal-tail leading edges had dorsal-type extensions. The horizontal stabilizer had fins. The dorsal extensions and the fins were added to make directional stability acceptable

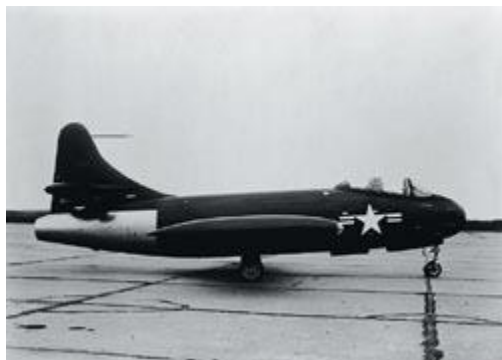
Engine

The basic engine for the F6U-1 was the Westinghouse J34-WE-30A rated at a 3200-pound static thrust less 12% for installation loss. The afterburner (Solar Model A-103B) produced approximately 30% boost by adding fuel to burn residual oxygen. The powerplant consisted of an 11-stage axial flow compressor, a double annular engine combustion chamber, and a two-stage turbine, plus the afterburner combustion chamber, two-position nozzle, cooling shroud and controls. Engine-driven accessories consisted of an all-speed governor, main and emergency (automatic) fuel pumps, lubricating system pump,

hydraulic pump and generator. The engine compartment was cooled by air taken in by boundary layer ducts at the wing roots and exhausted at a gill forward of a firewall on the bottom centerline. The afterburner compartment was cooled by air entering through two flush scoops on the lower fuselage aft of the firewall and out by nozzle shroud ejector action.
